DEPARTMENT OF THE NAVY
UNITED STATES FLEET FORCES COMMAND
1562 MITSCHER AVENUE SUITE 250
NORFOLK VA 23551-2487

5830
Ser N00/151
7 May 19

Subj: COMMAND INVESTIGATION INTO THE DEATH OF ENS SARAH JOY
MITCHELL, USN, AT SEA, ON 8 JULY 2018

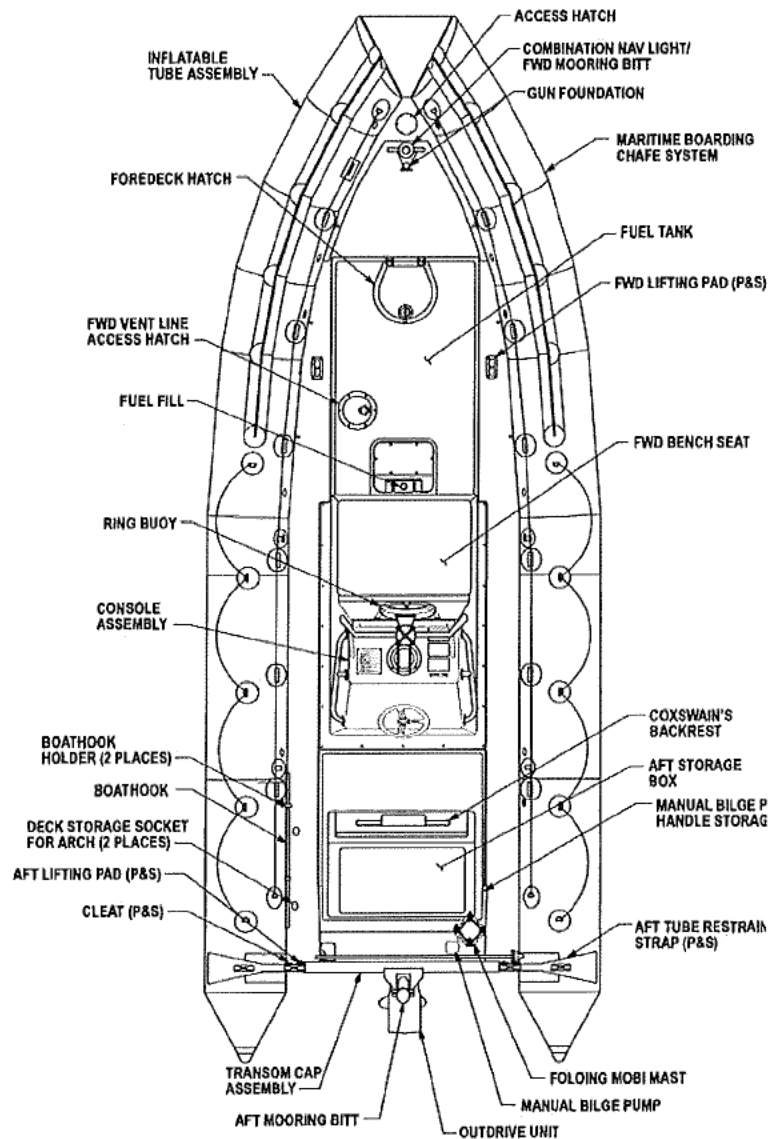
Figure 1, sourced from Reference (b)

77. Immediately before breaking away, ENS Mitchell directed personnel to hold onto the inboard line, see figures 1 and 3, between their legs when seated on the sponson. [Encls (28), (29)]

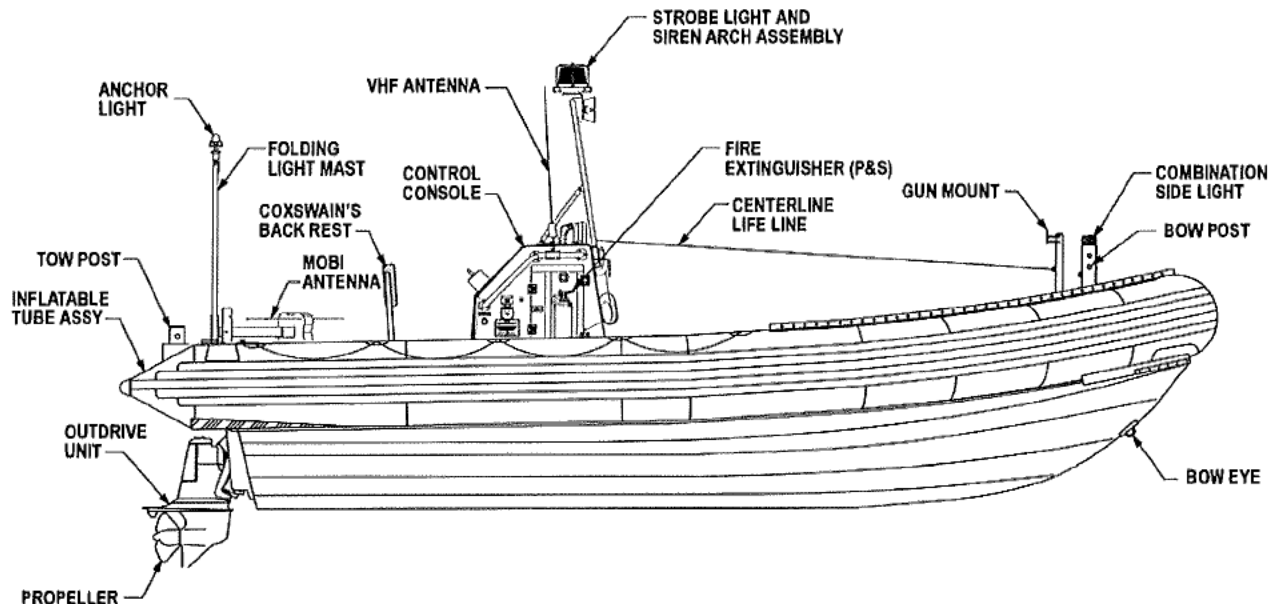
Figure 2, sourced from reference (b)

- e. There were five people sitting along the starboard side of the RIB. [Encls (8), (20)]
- f. There were two additional passengers on board during the second trip versus the first one. [Encl (9)]
- g. (b)(6) and (b)(6) rebalanced personnel within the RIB. [Encl (10)]

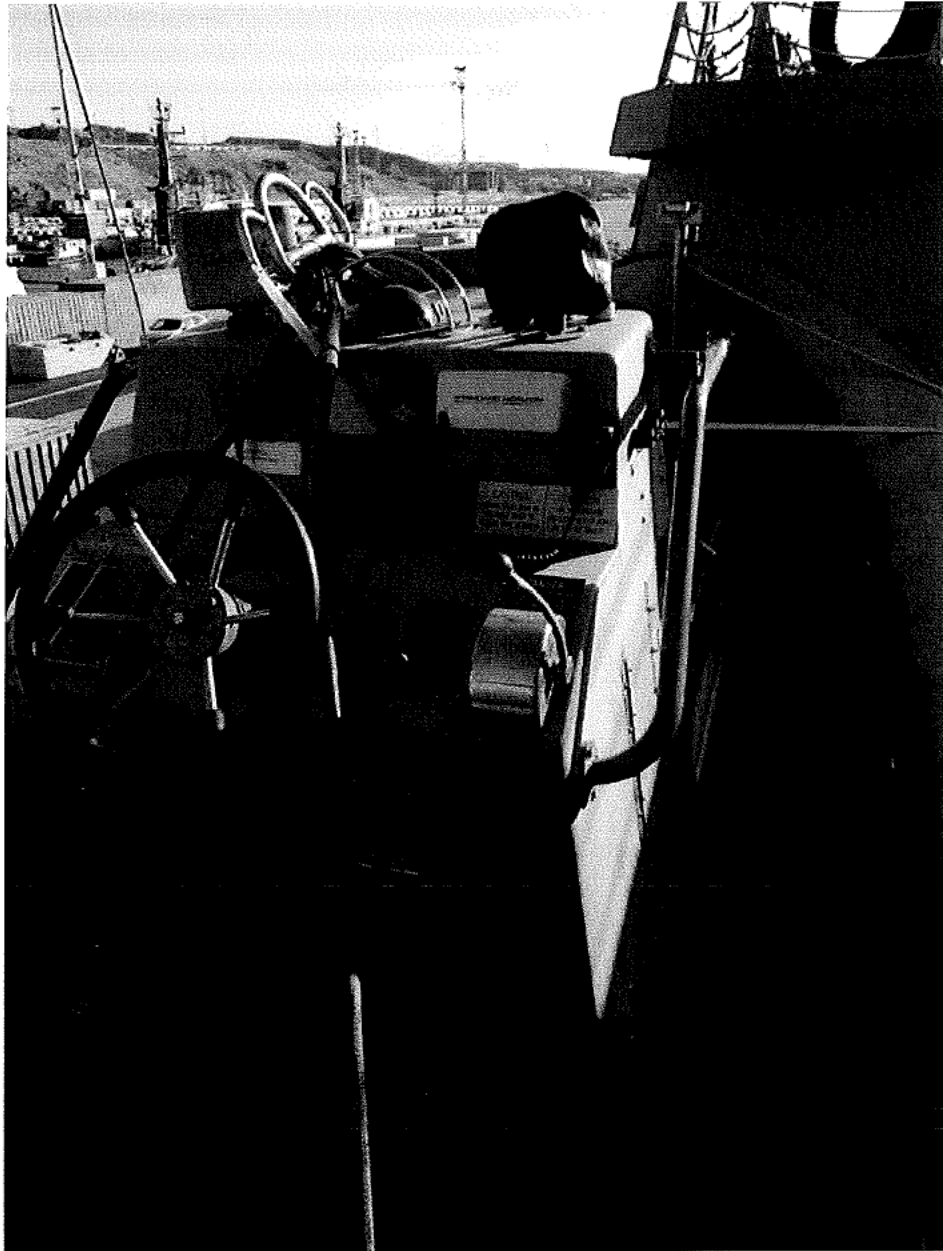
Figure 4, Investigator's photograph of helm

97. (b)(6) pulled himself up using the helm and started the turn to starboard to straighten out. He was not able to pull back the throttle before there was a second impact. [Encl (9)]

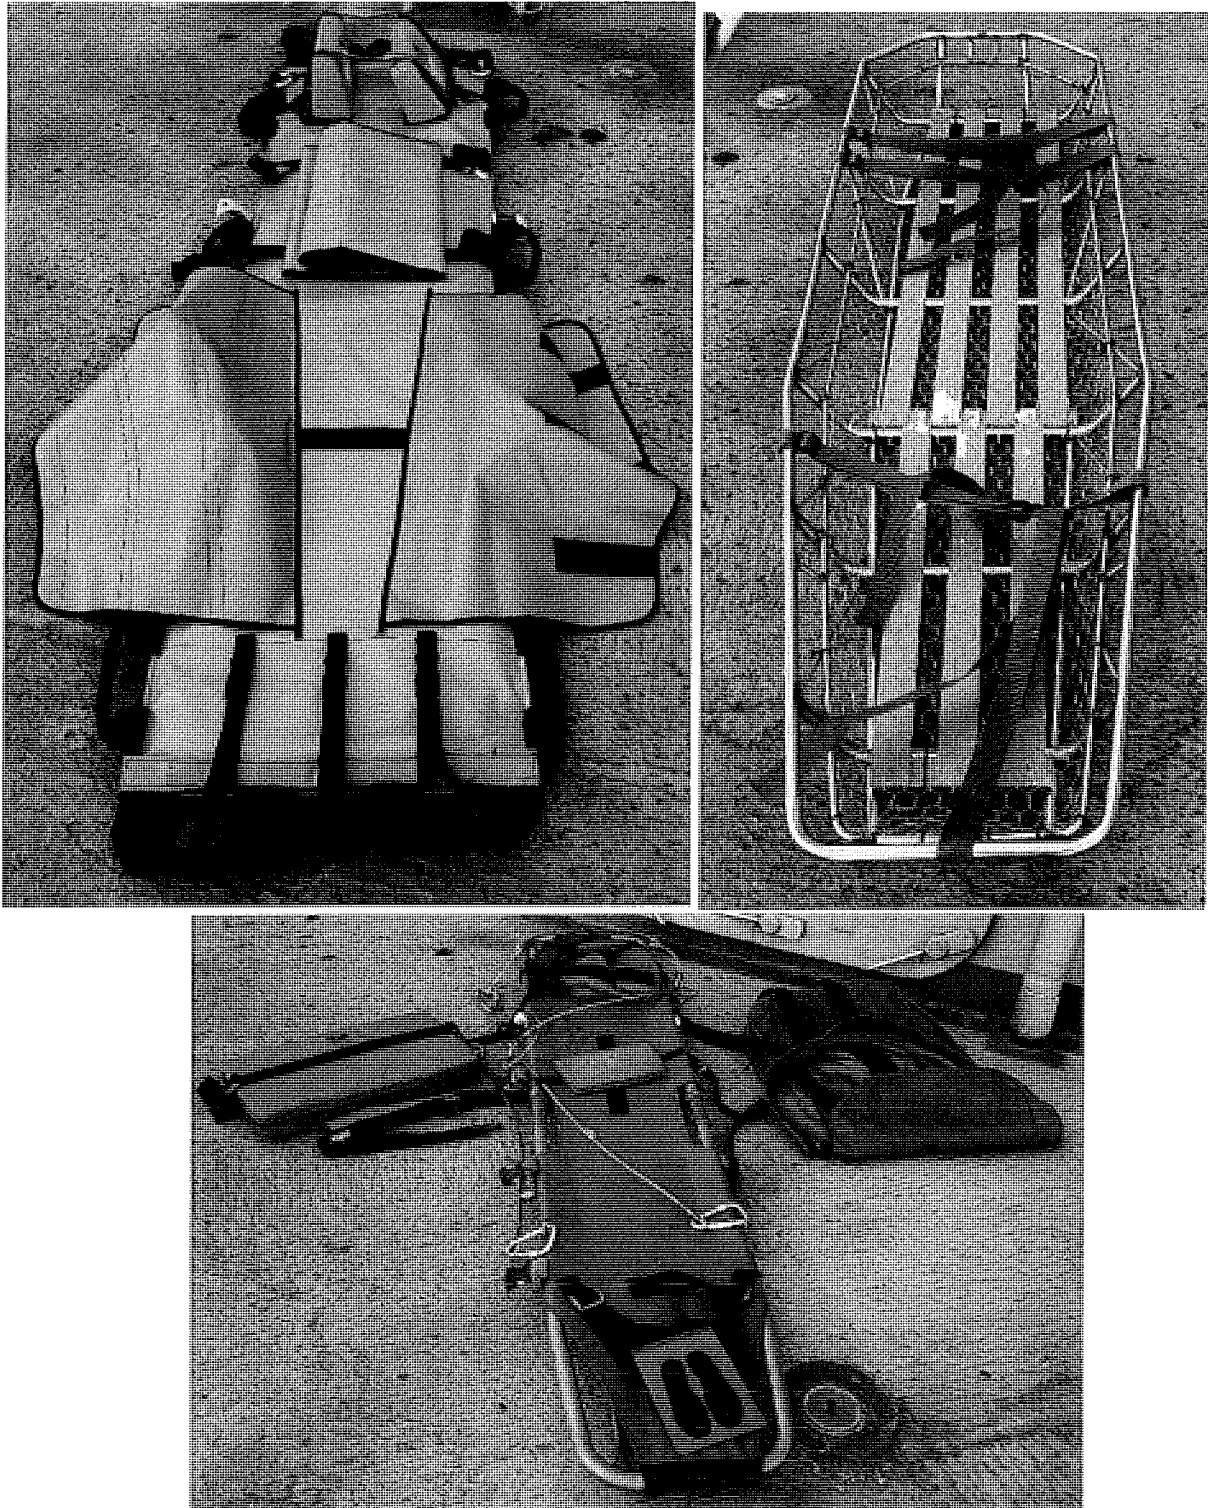
Figure 5, Clockwise from upper left corner: Investigator's photograph of the JASON DUNHAM Reeves sleeve; Investigator's photograph of the JASON DUNHAM Stokes litter; Investigator's photograph of the JASON DUNHAM SAR litter

Shortly thereafter the boat deck lowered down the Stokes Litter, which shocked me. It is not configured for recovery, nor does it have installed flotation for over-water rescue. Nevertheless, we transferred the patient in a coordinated effort to the litter and I continued compressions while the crew tightened down the straps. A cervical collar might have been appropriate here, except that the condition of the jaw and skull was such that 1) application might cause further injury, or 2) crush or block the airway, and, furthermore, 3) in support of the neck, the cervical collar must form a bridge between the collarbones

The Reeves Sleeve only had a single hoisting attachment, so the patient went up vertically. About halfway up the side the heaving motion caused her head to slip out of the headband and fall. This was absolutely horrifying and had a tremendous effect on the boat crew.

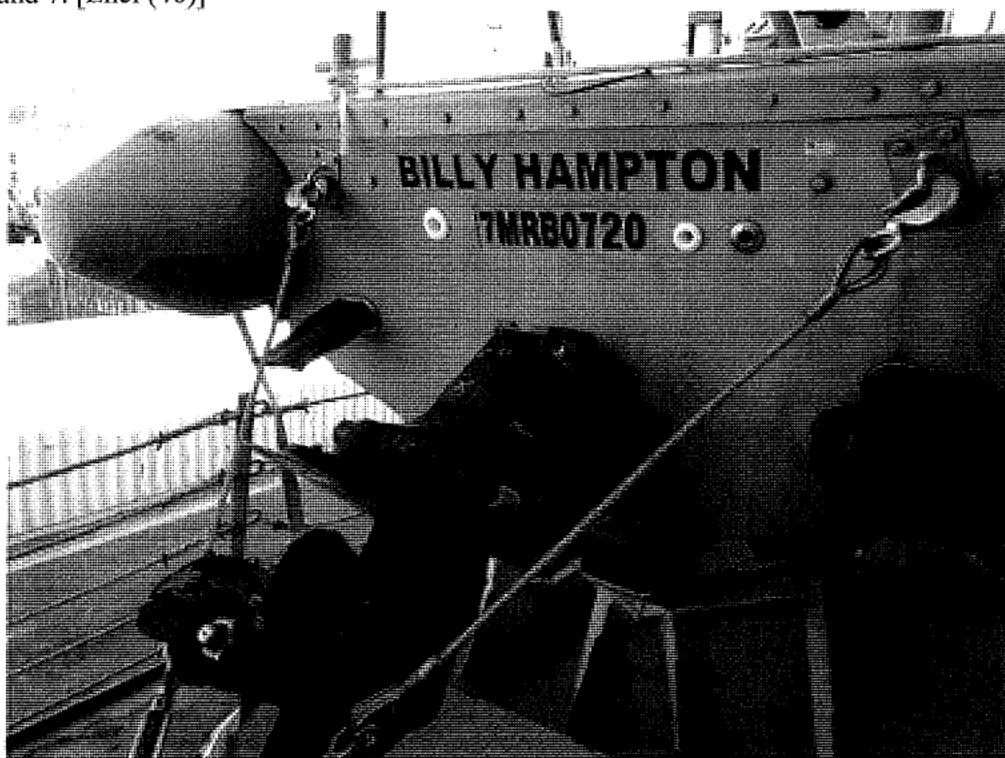
Figure 6, Investigator's photograph of the RIB BILLY HAMPTON

239. (b)(6) observed damage to the propeller of RIB BILLY HAMPTON. Specifically, he observed a gouge on the leading edge of one of the propeller blades and unknown fibers caught in the gouge, see figures 6 and 7. [Encl (48)]
